## Chapter 11

# Overview of Homesteads, Manhattan Project Resources, and Early Cold War Resources Impacted by the Cerro Grande Fire

*Ellen D. McGehee, Kari L. M. Garcia, and John Isaacson*

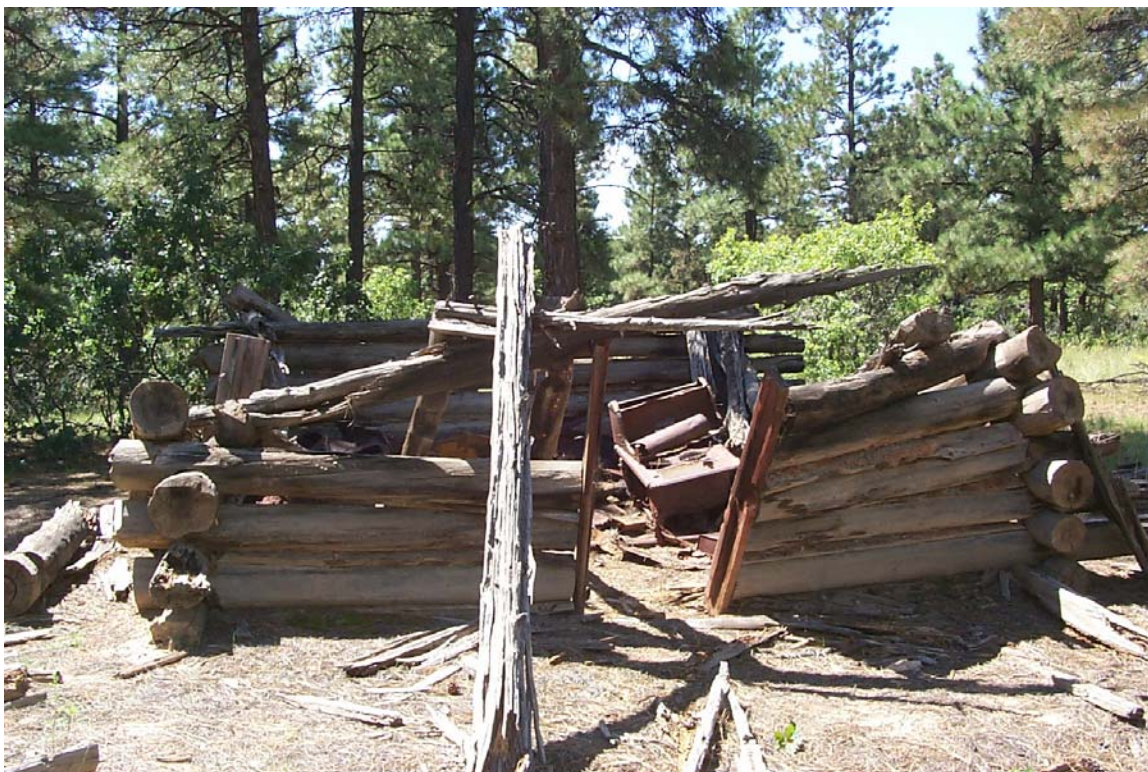
**Figure 11.1.** LA 21334, the Montoya cabin on Two-Mile Mesa before the Cerro Grande Fire.

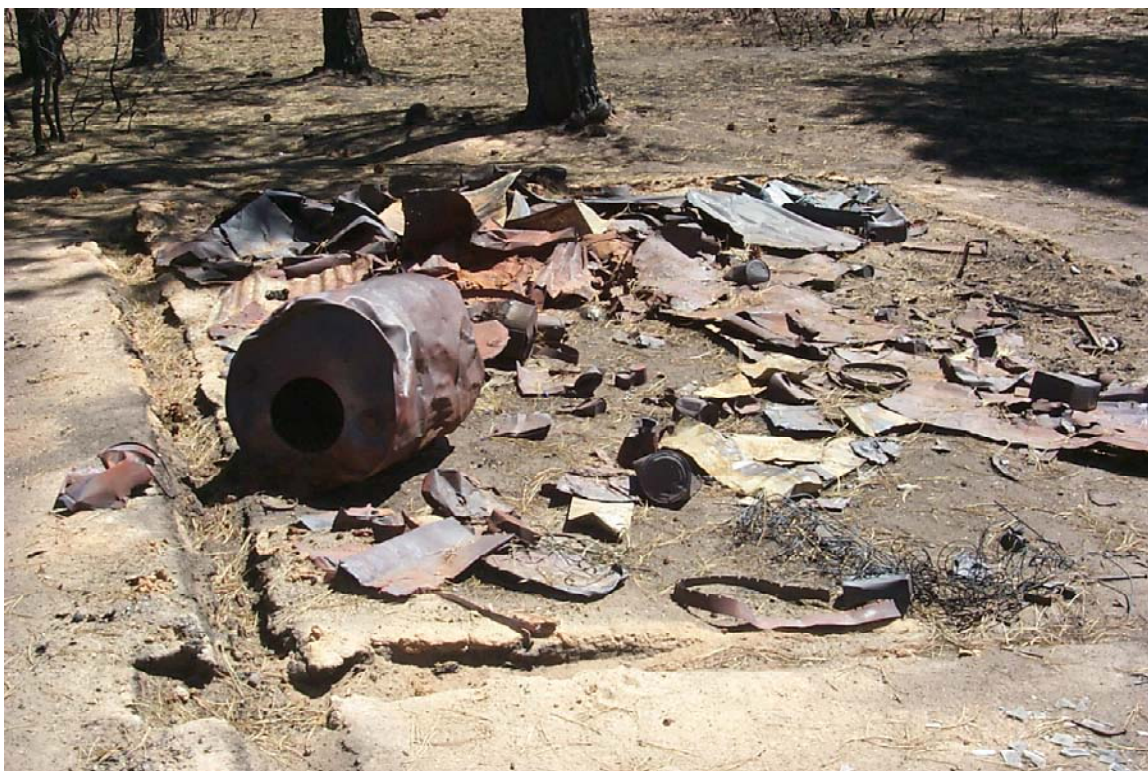
**Figure 11.2.** The Montoya cabin after the Cerro Grande Fire.

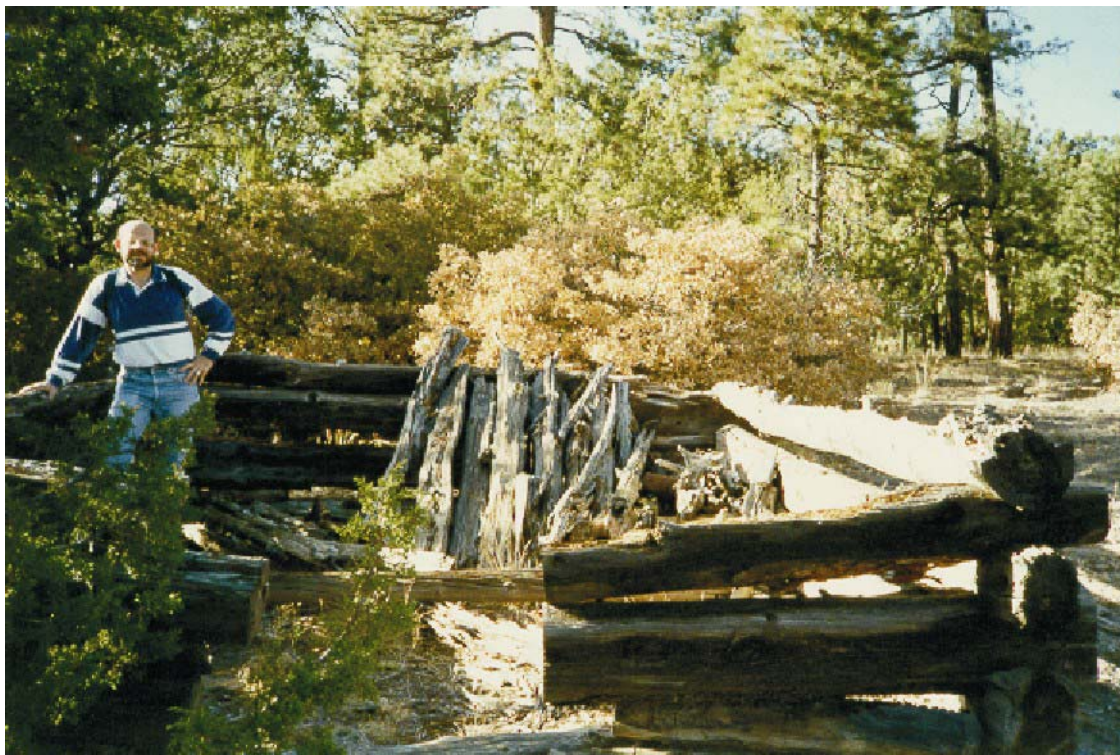
**Figure 11.3.** U.S. Forest Service Homestead Era site, LA 12710, the “Line Camp” before the Cerro Grande Fire.

There are a number of additional Homestead period sites and features located within the burned area perimeter at LANL. These sites, discussed in greater detail in Chapter 12, include isolated trash scatters and animal pens, wagon road segments, drainage-control and water-retention features, and temporary shelters. Homestead Era wooden resources on nearby U.S. Forest Service land were also totally consumed by the fire. Forest Service losses include the Garcia cabins and the "Line Camp" cabin north of Rendija Canyon (Figures 11.3 and 11.4).

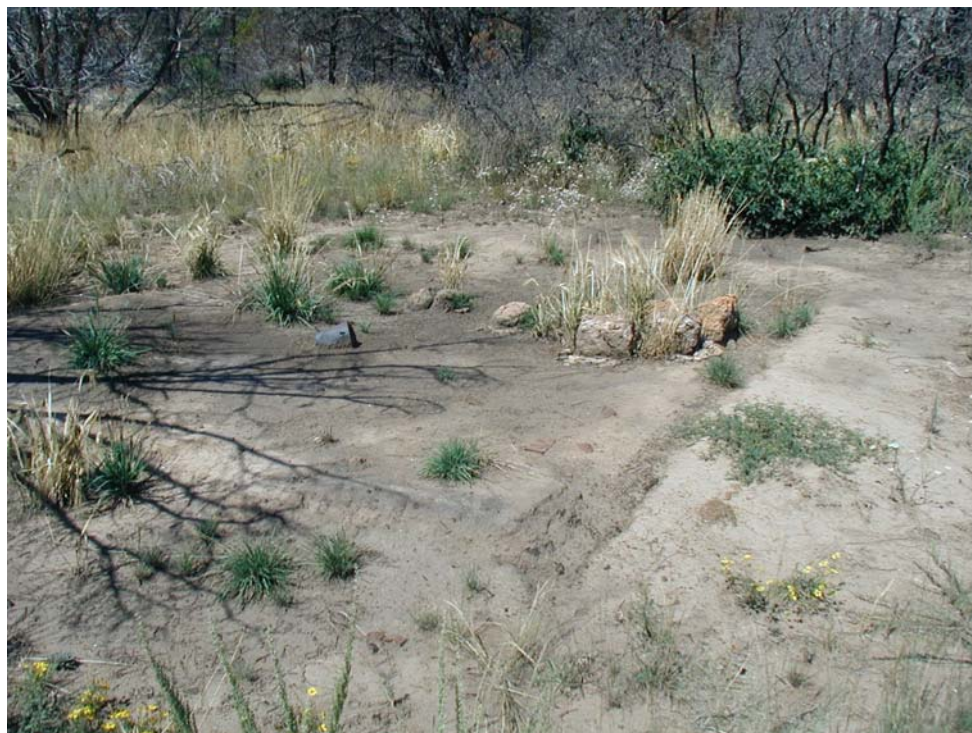
**Figure 11.4.** The “Line Camp” after the Cerro Grande Fire.

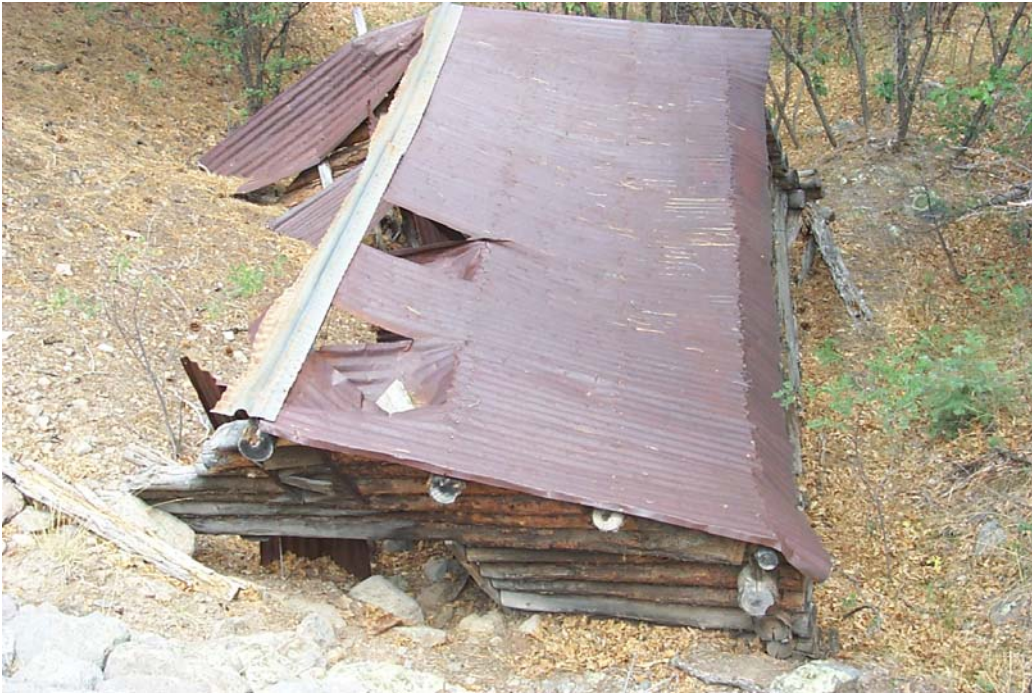
**Figure 11.5.** The Ice House at Anchor Ranch (pre-flood and pre-fire).

On June 28, 2000, an intense rainstorm caused significant flooding along West Jemez Road. This flooding event damaged State Route 501 in Water Canyon and destroyed the Anchor Ranch Ice House (Feature 1 of LA 16808) in TA-8. A nearby Homestead period wooden (LA 89826) appears to have been likewise destroyed by this flood (see Chapter 12). Due to the severity of this flood event (see Figures 11.5 and 11.6), which was triggered by the high severity burn on U.S. Forest Service lands upslope from TA-8, it was feared that this presaged one or more seasons of additional flood damage to facilities and cultural resources at LANL. This situation helped to spark the construction of flood retention structures in several canyons, and the placement of protective cement barriers around the historic Pond cabin (LA 21973) in Los Alamos Canyon. Fortunately, in the nearly 2.5 years since the destruction of the ice house and bridge, no other cultural resources have been impacted by fire-enhanced flooding.

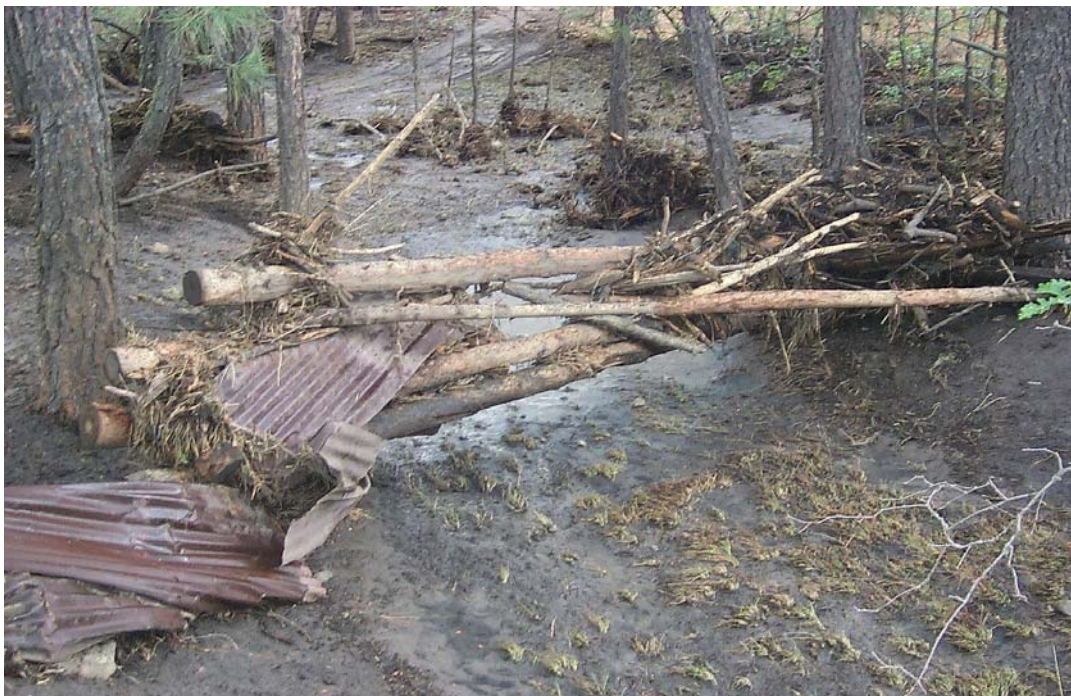
**Figure 11.6.** The Ice House (post-flood and post-fire).

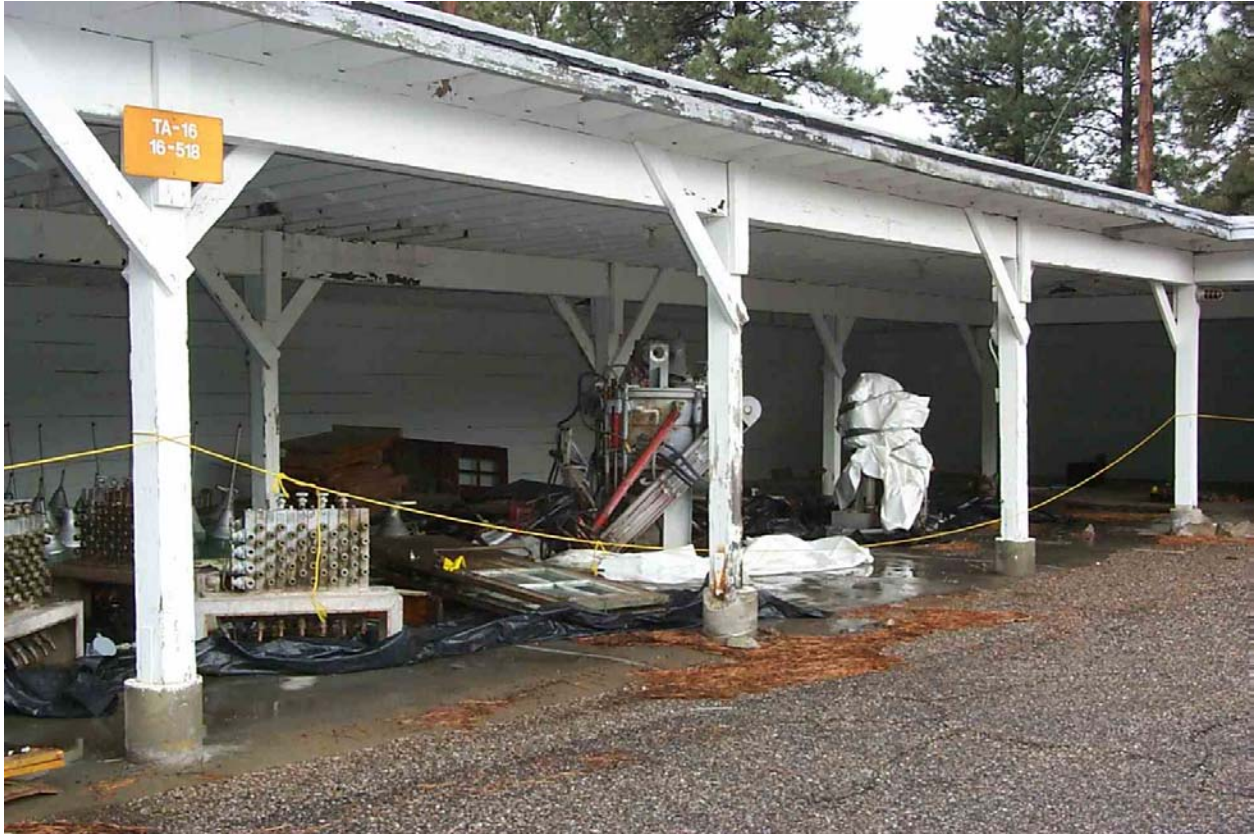
**Figure 11.7.** Artifacts stored at V-Site before the Cerro Grande Fire.

Manhattan Project properties were also lost on May 11, 2000. When the Cerro Grande Fire burned across LANL's high explosives testing area, four of six properties at V-Site were destroyed. Luckily, Building TA-16-516, the Trinity device assembly building, remained untouched. Before the fire, an open wooden shed at V-Site was being used to house historic casting equipment salvaged from another Manhattan Project building (Figures 11.7 and 11.8). The shed and all combustible artifacts were burned. Other metal and glass artifacts were either melted or severely damaged by the effects of the fire.

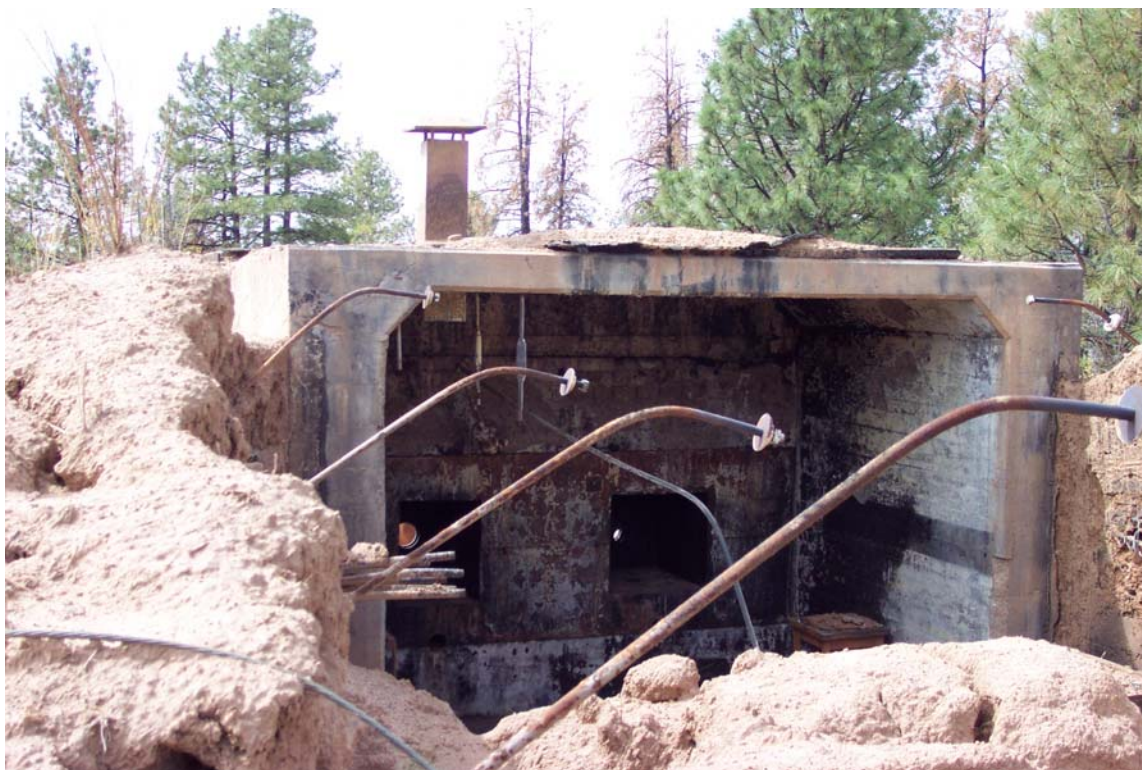
**TA-14-5.** TA-14-5 was constructed in 1944. The building was originally used as a control room and was of wood-frame and concrete construction. In 1961, the function of the building changed from a control room to a storage area. The wooden part of the building was destroyed during the Cerro Grande Fire. The small concrete bunker is still standing (Figures 11.9 and 11.10).

**Figure 11.9.** TA-14-5, remaining concrete portion and berm after the Cerro Grande Fire.

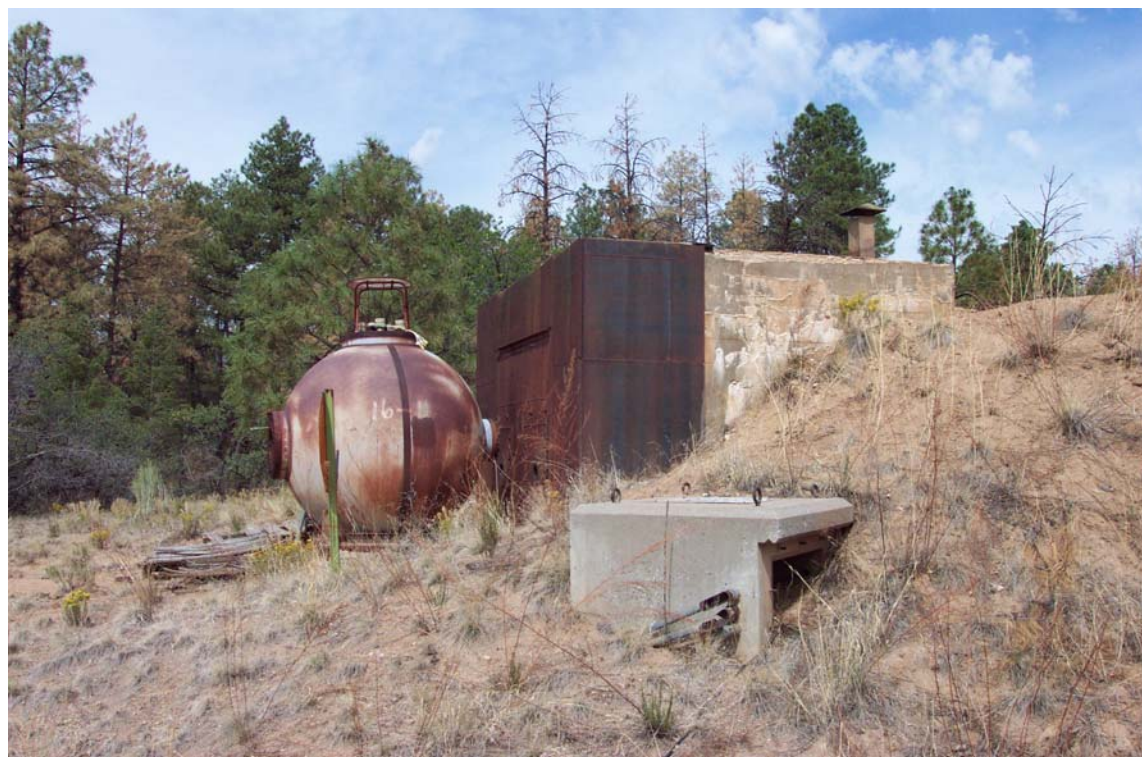
**Figure 11.10.** TA-14-5, rear view of former control room and berm after the Cerro Grande Fire.

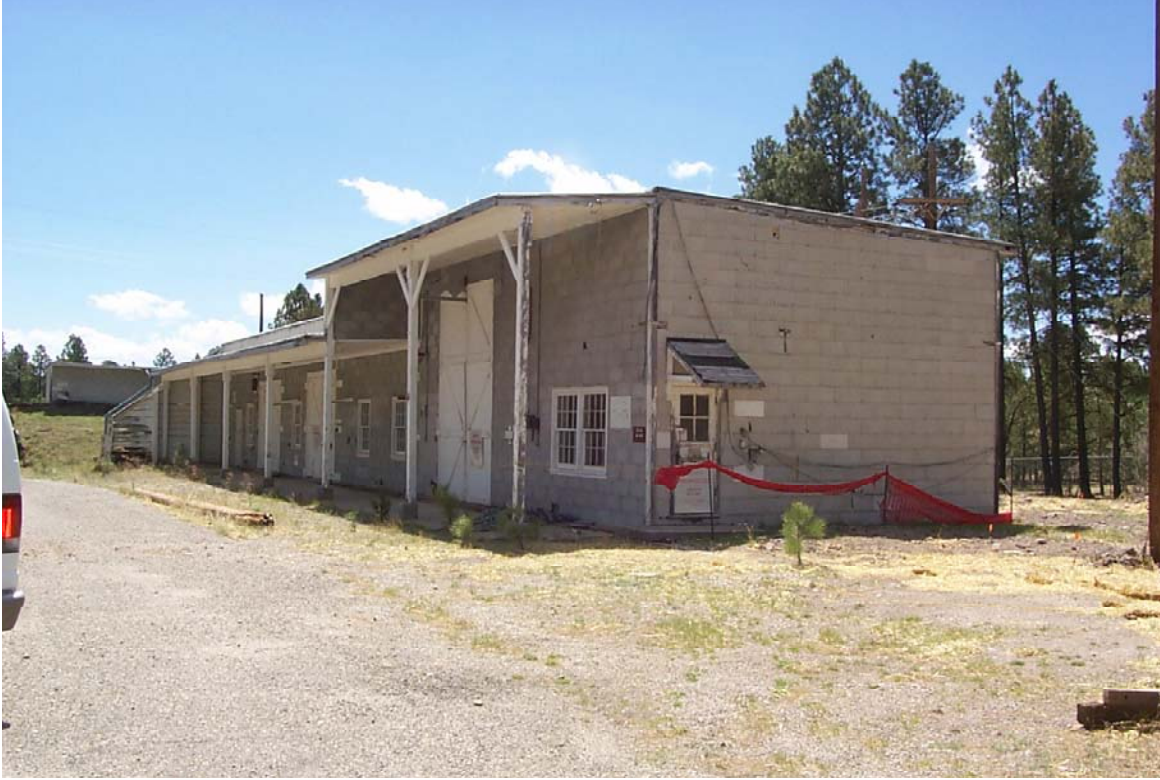
**V-Site.** TA-16-515 (originally V-1 and V-2) was built in 1944 and was completely destroyed by the fire (Figures 11.11 and 11.12). It was a wood-frame building with a low-pitched roof and a concrete foundation. There were asbestos shingles on the exterior of the building, and the south and east sides of the building were barricaded with an earthen berm. This building was a high explosives processing building (McGehee 1995).

**Figure 11.11.** TA-16-515 at V-Site before the Cerro Grande Fire.

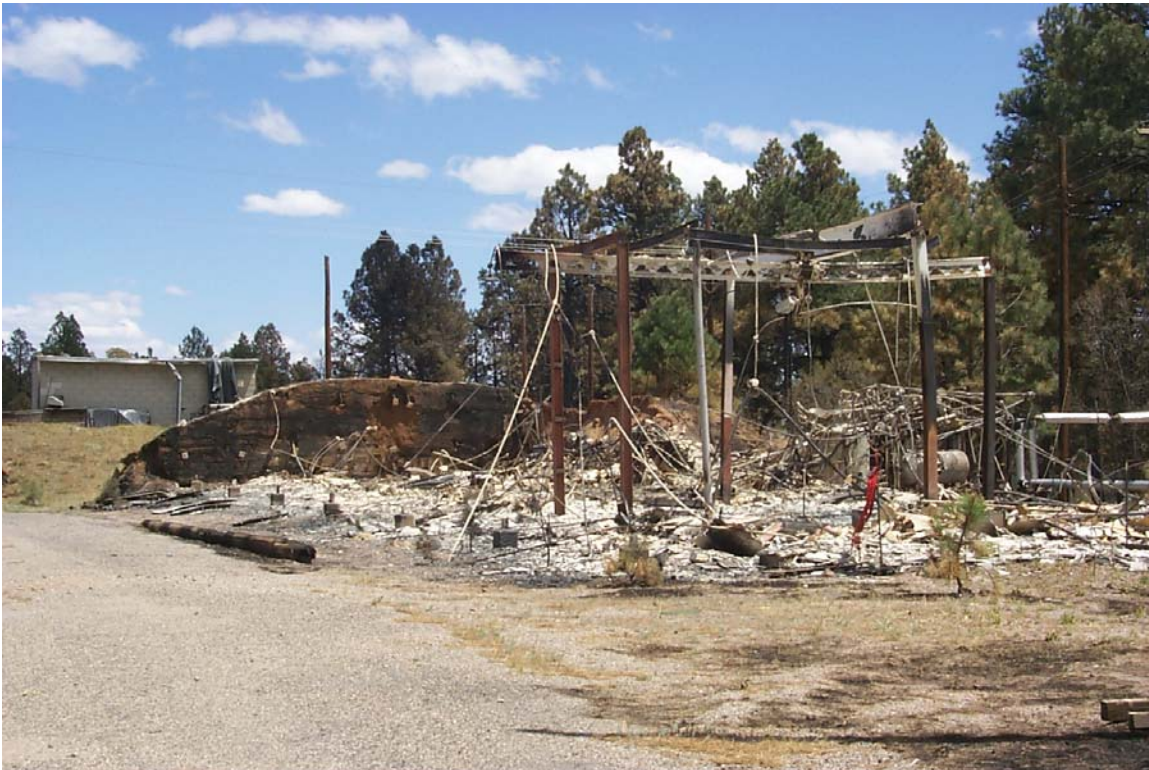
**Figure 11.12.** TA-16-515 after the Cerro Grande Fire.

A decision was ultimately made to leave the ruins of TA-16-515 in a post-fire state (see Figure 11.12) and to rebuild the original courtyard area around TA-16-516, the intact assembly building. To date, the

remains of TA-16-515 have been decontaminated of asbestos-containing material, and a large crane, associated earthen berms, and the foundation have been left in place.

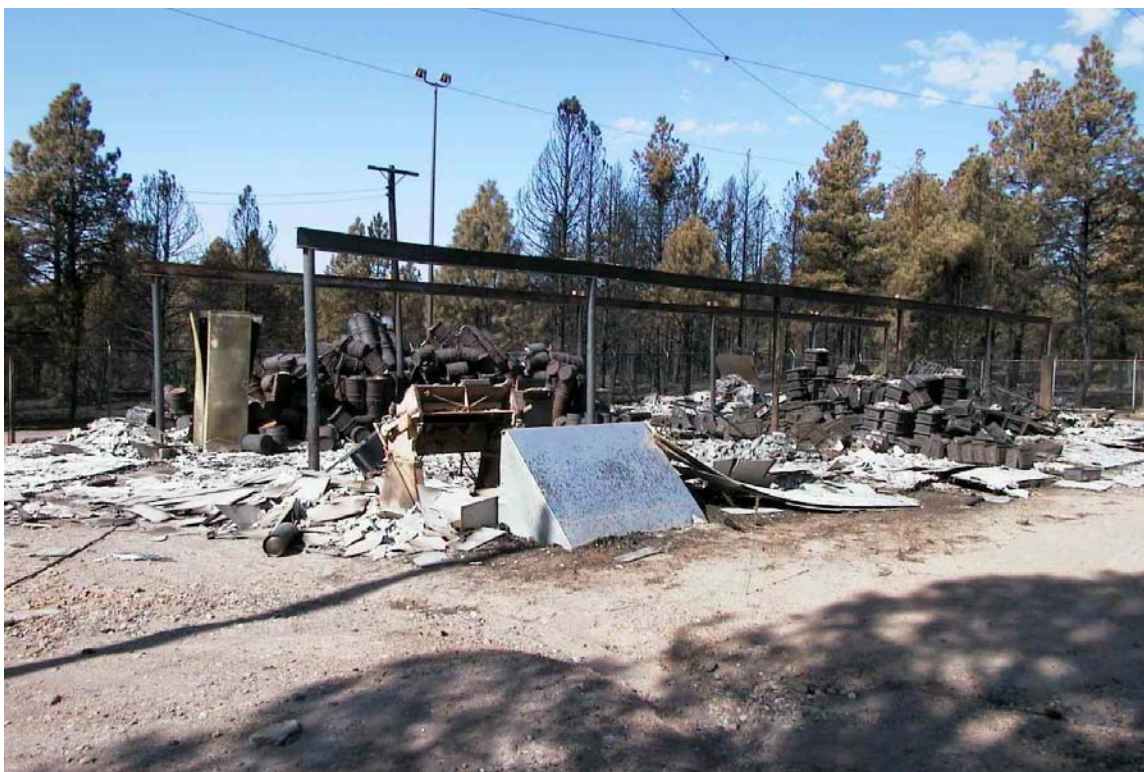
**TA-40.** TA-40-72 and TA-40-73 (originally TD-2 and TD-3) were completely destroyed in the fire (Figures 11.13 and 11.14). These two identical buildings were built in 1945 from the same plans and were used as general storage buildings. However, they were also identified as “magazines” on a 1955 Laboratory Structure Location Map and probably functioned at one time as explosives support buildings. They were wood frame with 2-in. by 4-in. studs and bracing set on reinforced concrete floors and appear to have had asbestos siding or shingles.

**Figure 11.13.** TA-40-72 after the Cerro Grande Fire.

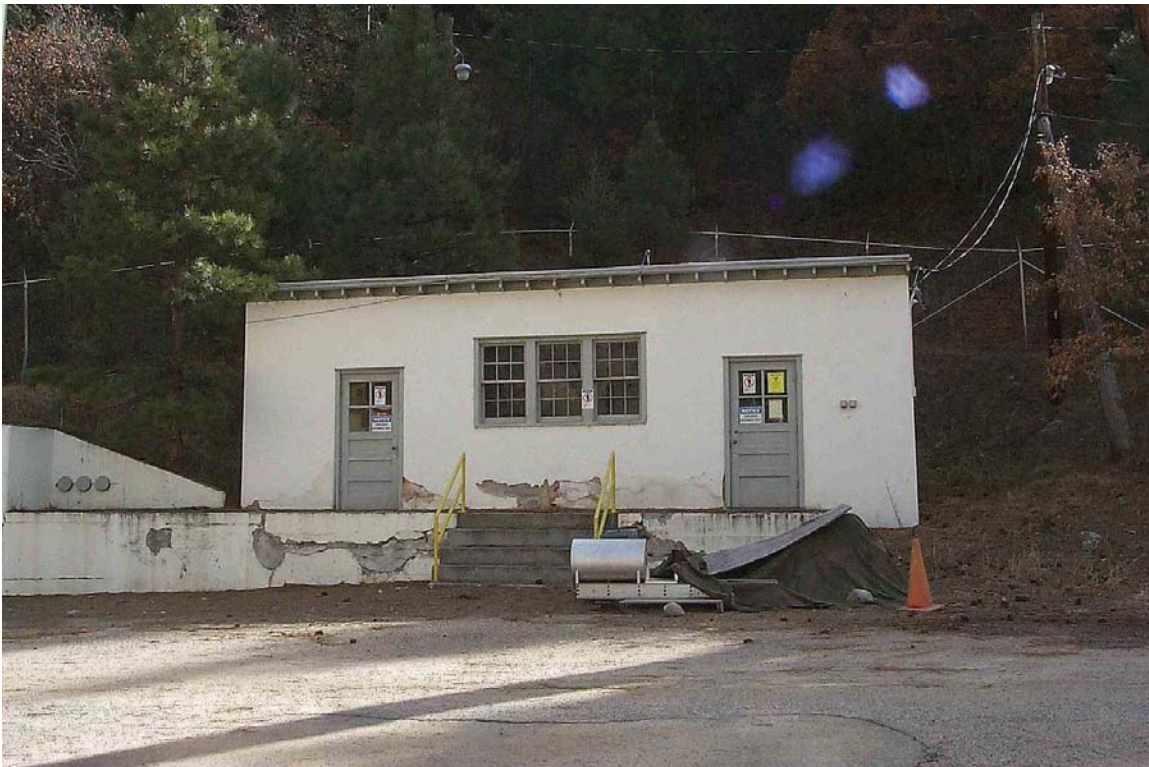
**TA-2.** The elevated risk of flooding in Los Alamos Canyon necessitated the emergency removal of TA-2-4, a small building at the historic Omega West Reactor facility (Figure 11.15). This building was built in 1947, and, although used primarily as a guard station, was once used to store radioactive material associated with the Omega West Research Reactor (McGehee 2000).

**Figure 11.15.** TA-2-4 in Los Alamos Canyon.

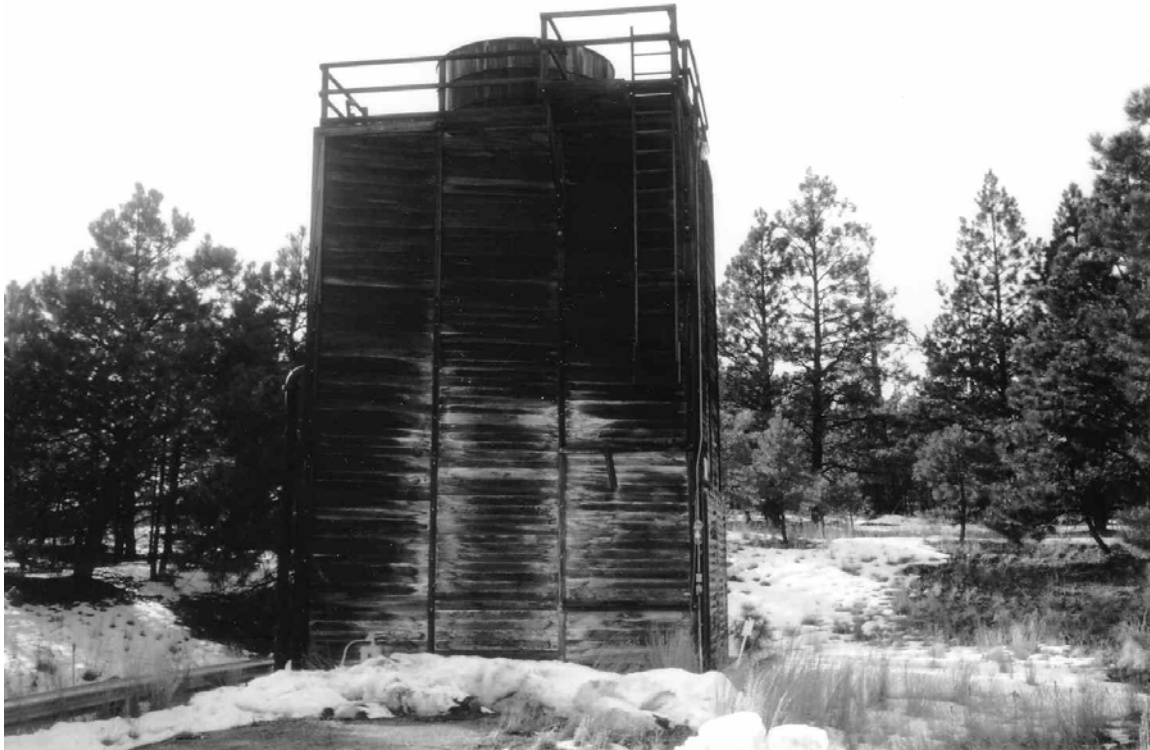
**TA-16.** TA-16-372 was a wooden cooling tower built in 1953 (McGehee 1995). It was located near TA-16-390 and was completely destroyed by the fire (Figures 11.16 and 11.17).

**Figure 11.16.** TA-16-372 before the Cerro Grande Fire.
